INCIDENT NOTICE

INCIDENT TITLE: 10 Mar 2021: Finland – sinking of a MEMU-truck

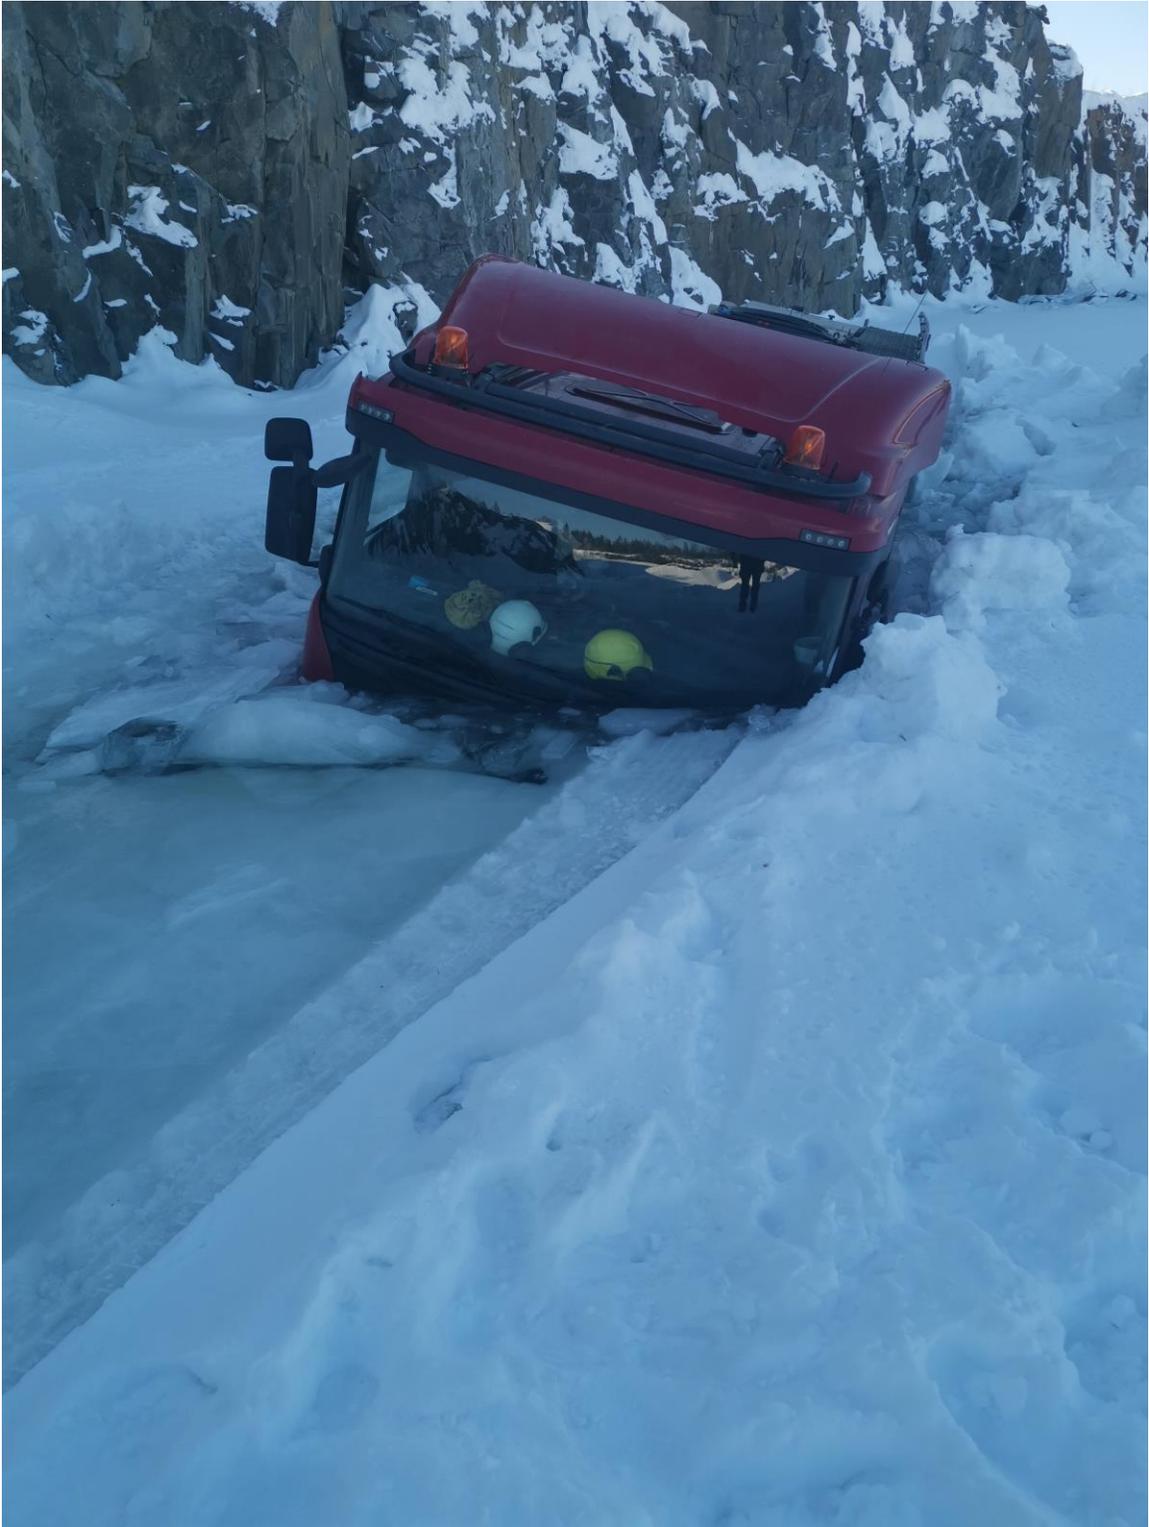
DATE POSTED	REFERENCE	SOURCE
6 May 2021	IN 21-14	Non-Member
INCIDENT OUTLINE		
When did it happen?	Wednesday, 10 of March 2021 at about 11.00 am	
Who experienced it?	Pyylähti Oy, Finland	
Where did it happen?	At a quarry worksite.	
What material was involved?	MEMU-truck, 13 000kg total payload.	
What happened?	At the beginning of a loading operation the MEMU-truck fell through ice and was immersed in water about 2 meters deep	
Why did it happen – theory?	The operators were instructed to drive to a road leading to the pumping site, the road was ploughed through snow and over ice that had formed over a pit of water. The road was apparently ploughed to a wrong location. The part of the road which went over ice was not marked in any way.	
What was the impact?	No injuries to personnel. The MEMU-truck was badly damaged due to water ingress of drivetrain and electrical control systems. The tanks of the MEMU remained intact and nothing leaked to the environment

MEMU in the water

Clients are recommended to provide a clear description of driving arrangements on worksites. Operator training to include escape training in case of truck sinking. Emergency hammers in the cabin.

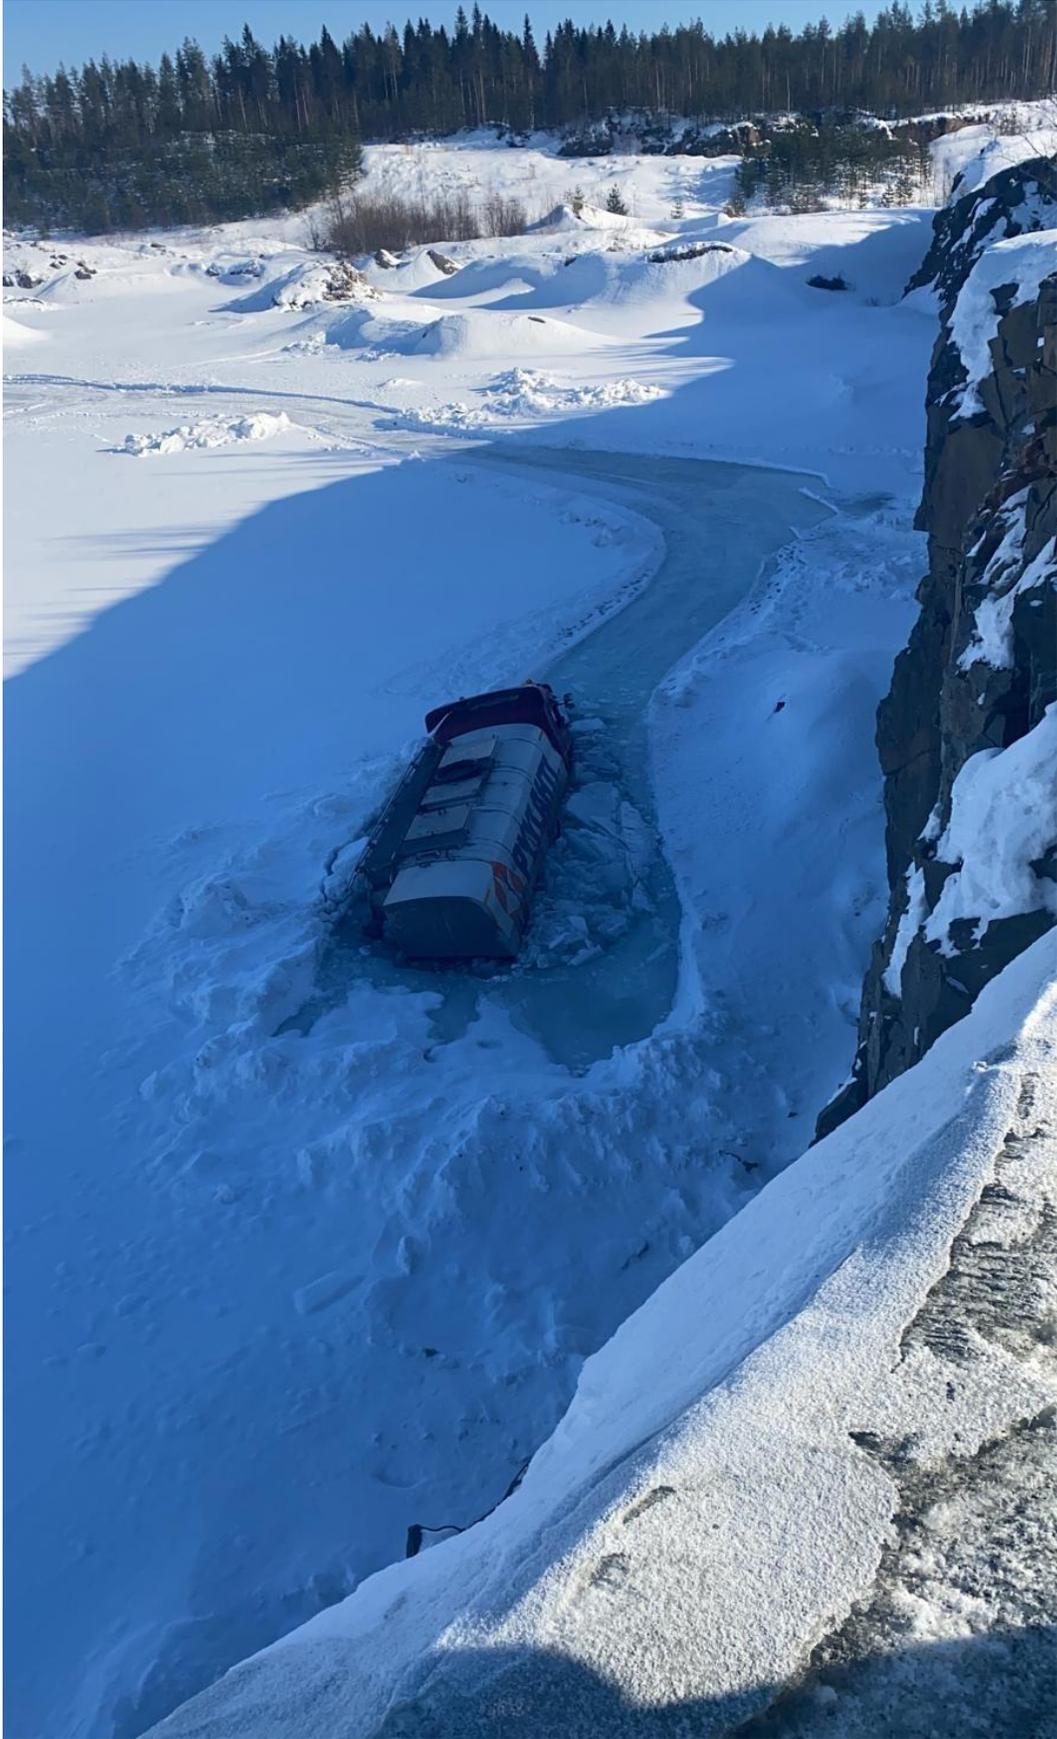
MEMU in the water

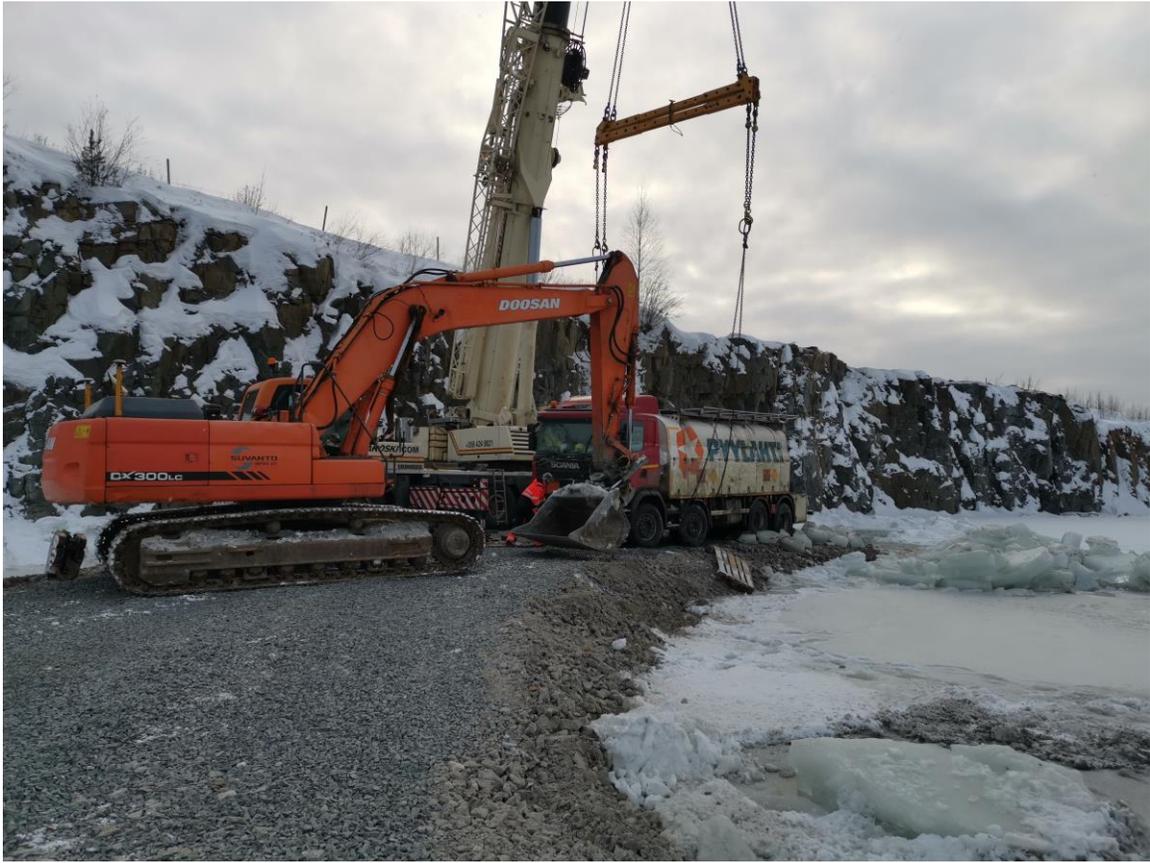
Lifting operation done

By draining the oil and water from the drivetrain of the truck almost immediately after the lifting was done and by filling the drivetrain back with oil, drivetrain damage was kept to a minimum. Ingressed water could not freeze and break the block and new oil prevented corrosion.
